Don't Blow that Tranny! Part 2 (unedited version)

by DAVID JUNG

Last month, we dropped off a toasted output transformer from a 1950 *Vox AC15* with Sergio Hamernik and the team at **Mercury Magnetics**. From a suspicious pin-sized burn in the transformer's outer paper insulation, they were able to determine probable causes for the transformers untimely demise. Then it was onto the rewind process! So, is it over for this amp's output transformer?

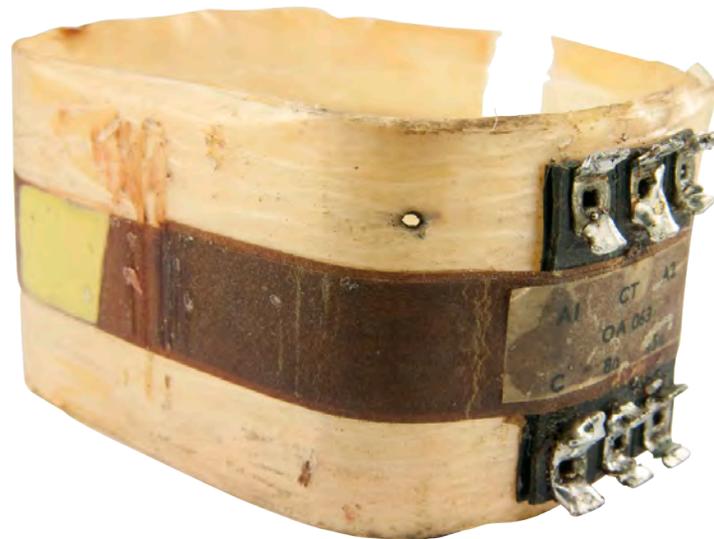
The perforated insulation is shown here. The good news is that it's salvageable, so **Mercury** will reuse it for the restoration – but with an appropriate amount of new insulation under it.

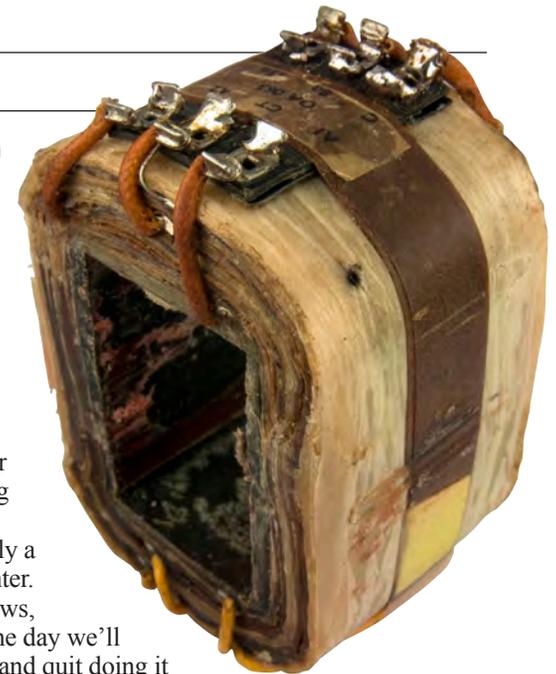
The transformer with its core removed. Note the burn mark.

Well the coil of your transformer quickly spilled the beans. Remember that small black spot we noticed on the outer wrap of the coil? Sometimes there are innocuous blemishes in the form of spots that may appear on the surface of paper and are nothing to worry about. However, what we normally find in fried transformers is that the burn begins somewhere in the middle of the coil and works its way out – causing an exit wound. In your case the failure was not typical. Yours was an entry wound.

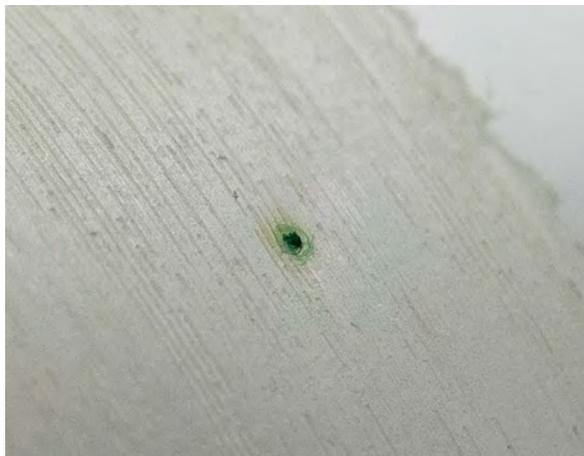
An extreme close-up of the burn mark at the first layer of insulation. Notice where the ionized copper left a green-colored mark.

killed by a sharp instrument that penetrated the outer insulation that broke through and severed two turns of the fine wire that make up 1/2 of your primary winding. Meaning that only one of the two power tubes was operational. The damage to the entire transformer was limited to that spot and only the very top layer of the magnet wire. Those broken wires were arcing across each other and taking advantage of the oxygen available from the perforation of the outer wrap to form that black spot. Further evidence to support these findings is the fact that the rest of the winding, all the way down to the bobbin, was unharmed.

This type of injury is caused by the usual suspects – the installer or remover of the transformer. The smoking gun possibilities are: the tip of a soldering iron, the tip of a Phillips screw driver... or rough handling (dropping or bumping the transformer against something sharp, etc.) with enough force to puncture it to cause such a failure. And finally, we cannot rule out beer as another possibility.

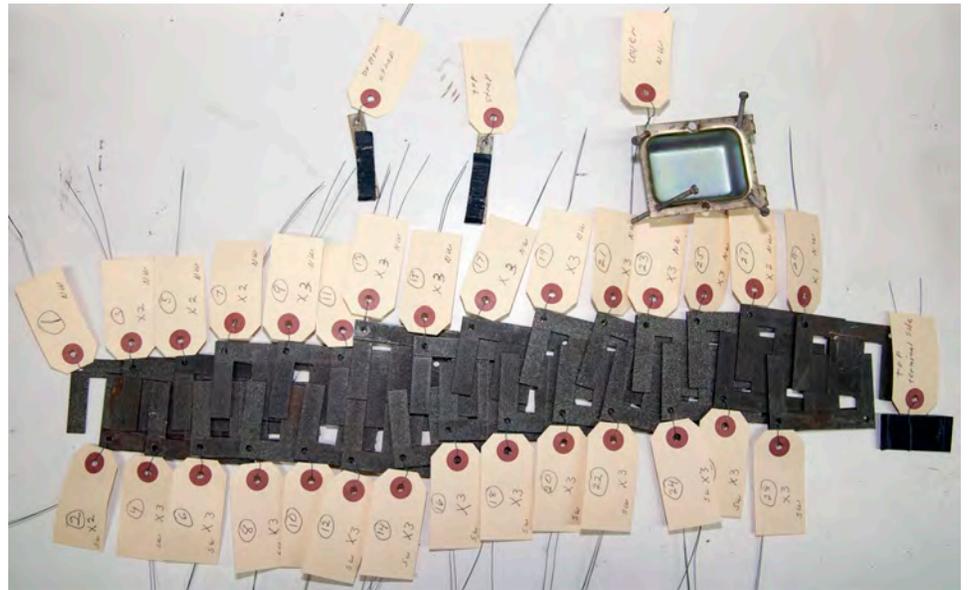
The AC15's transformer after it was fully disassembled.

it. So the first thing we do is remove the core stack and catalog each plate for original position and sequence. Check out the photo of your core completely apart and tagged. We did find some rust and will do our best to preserve it.

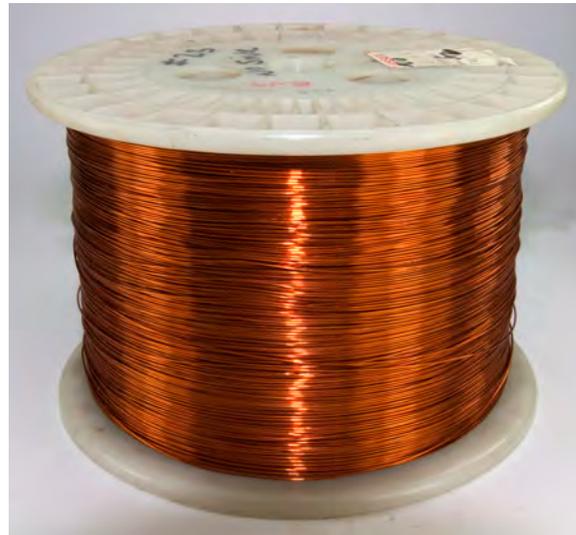
A sample of wire we're going to use for the restoration.

That brings up a couple of interesting and important points. First, Mercury is probably the only company in this industry that uses high-purity OFC (oxygen free copper) magnet wire made in here the U.S.A. – which we use exclusively because of its guitar tone (as well as our hi-fi audio) properties. This type of wire is clearly sonically superior and more consistent than the wire that was used in the '50s and '60s. Wire technology back then was limited to about half of the temperature and electrical performance of Mercury's standards. As a result, transformers using our materials last longer, take

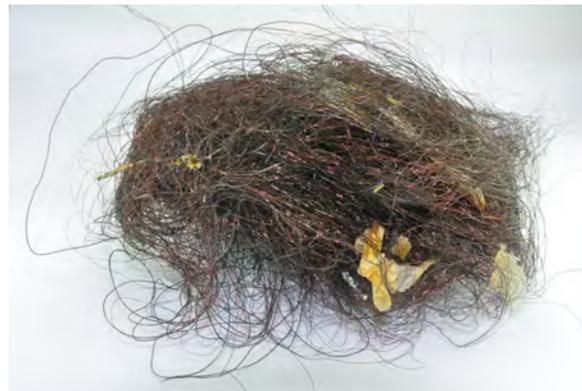
This is what your wire looks like when it's unwound from the transformer.

Magnet wire is not bare copper wire. There is a micro thin coating of plastic insulation that protects it from shorting. That very thin layer of plastic is susceptible to microscopic spider web-like cracking. And the process of unwinding the magnet wire virtually assures it's going to get damaged.

Check out the photo of what the magnet wire from your transformer looks like after it was unwound. Does this look like something you'd want to put back in your transformer?
